CORROSION TESTING WITH REAL-TIME 2-D ULTRASOUND CAMERA IMAGING

Corrosion Testing with Real-Time 2-D Ultrasound Camera Imaging

Editor's Note: This is another example of technological cross-sharing. This technology migrated from the aerospace industry. Use of this particular technology is already transferring to the process industries as the following trial cases illustrate.

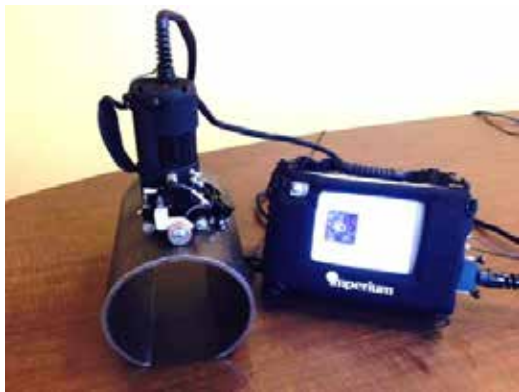
Figure 1. Acoustocam™ with encoder and dual-element transducer on an 8" pipe.

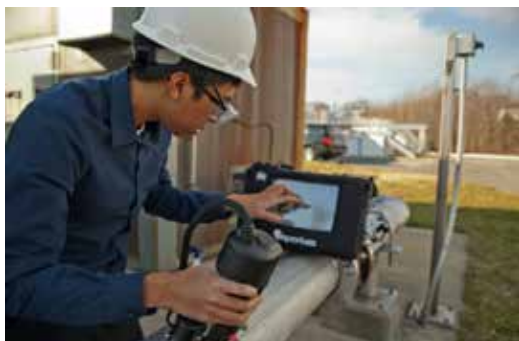
Figure 2. NDT technician performing field inspection.

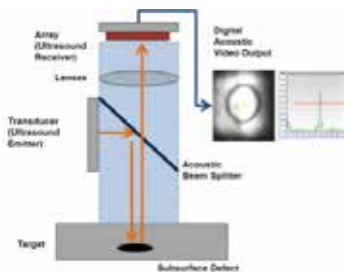
The system can generate C-scan images in real time. As shown in **Figure 3**, a transducer emits sound waves which are reflected by an acoustic beam splitter onto the metal target. The sound waves are reflected back through the acoustic beam splitter, a water-filled tube, and an acoustic lens that focuses them on a microelectronic ultrasound-sensitive detector array that produces a digital acoustic image. The detector array, shown in **Figure 4**, is highly sensitive – it is made up of 120 by 120 pixel elements (i.e. 14,400 pixels) - and is able to generate and record C-scan images at specific depths within a target object at the rate of 30 frames per second, similar to a conventional camcorder.

Figure 3. Optical imaging techniques were applied to ultrasound.

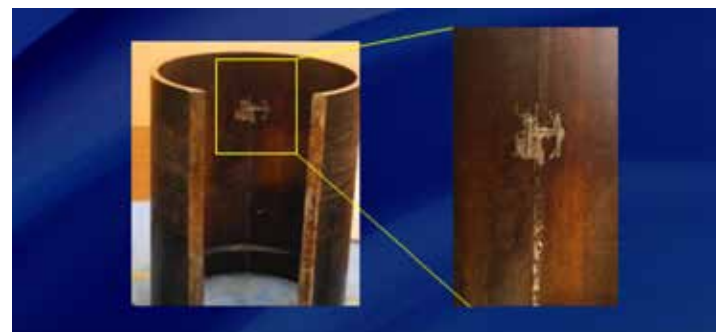
Figure 5: Steel pipe with “H” carved into rear side.

For this article, an inspector used the system to scan an 8” diameter steel pipe with an “H” carved into the rear side to simulate backside corrosion, as shown in **Figure 5**. As shown in **Figures 6 and 7**, the corresponding corrosion maps clearly show the damaged area and the individual thickness readings. **Figure 8** is a snapshot of the display screen showing simultaneous real-time C- and A-scans.

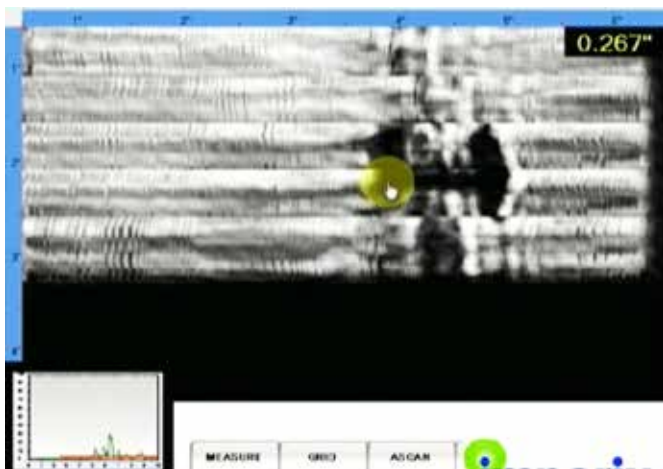
Figure 7. C-scan images of 8" diameter steel pipe with thickness reading of 0.267" at damaged area.

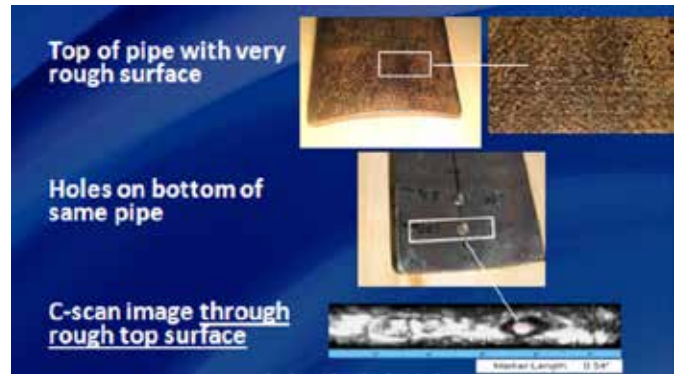
In a second pipe test, an inspector used the system to scan a section of rough, curved steel pipe. As shown in **Figure 9**, C-scans allow the inspector to locate the damaged back side area with surprising clarity.

Figure 9. Images from scan of an 8" rough curved pipe section.

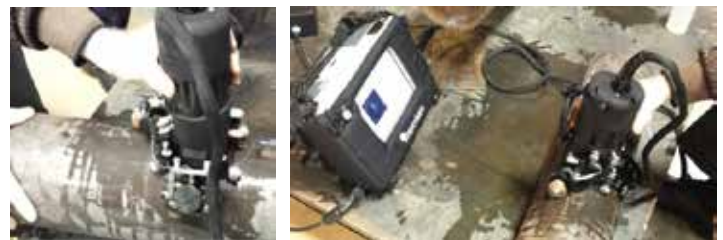
In yet another pipe test, the system was used to inspect a 6" diameter heating pipe from a North American coatings and specialty products manufacturing facility. While largely free from corrosion, the back wall of the 3/8" thick pipe had a large area of thinning and pitting from years of condensate buildup. As shown in **Figures 10 and 11**, the device was mounted on a trolley specifically designed for piping applications in order to guarantee perpendicular imaging. As shown in **Figure 12**, the inspector was able to generate a 2-D C-scan image that showed the thinning and pitted area.

Figures 10 and 11. Inspection of a 6" steel pipe.

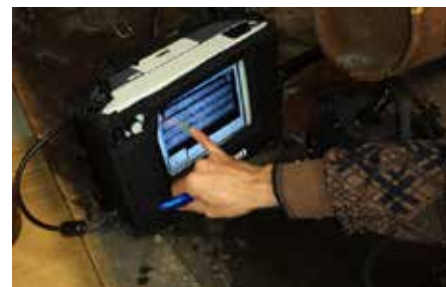
Figure 12. Inspector identifies thin area of 6" steel pipe using the 2-D C-scan as a guide.

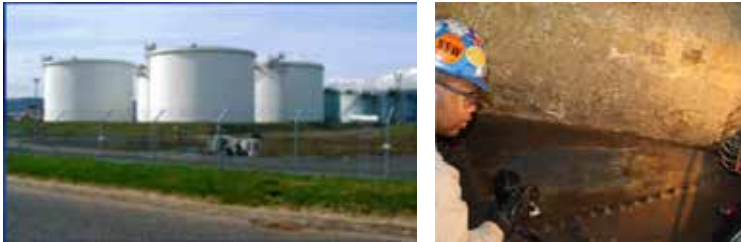
Figure 13. A technician in the field inspecting petrochemical storage tanks.

Storage tank bottoms have their own specific issues as leaks are not always readily visible to the naked eye. The tanks could experience serious losses before the owner even suspects a problem. Inspectors need to be able to see underneath the tank floor to look for corrosion that can lead to leaks. Corrosion problems can start small but quickly grow

into bigger problems. Typically, magnetic flux test leaking (MFL) is performed first on a storage tank bottom, and then is followed by an ultrasound flaw detector. The study that follows shows that the system can serve as a quicker, more quantitative method of performing UT prove-up than a flaw detector.

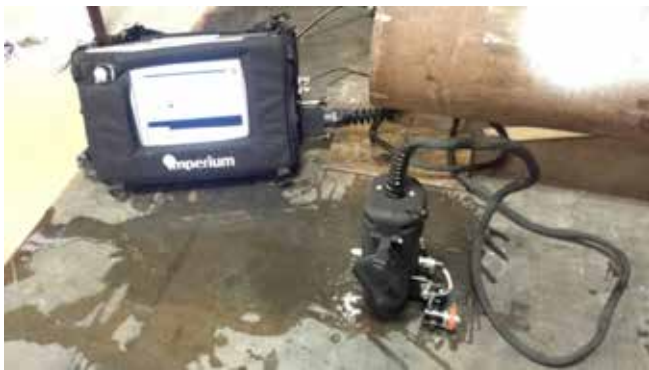
One storage tank section is shown in **Figure 14** below. An inspector was able to set up the device, calibrate it, locate the area of corrosion, and create a 2-D C-scan – all in less than 5 minutes.

Figure 14. The system being used on a storage tank bottom cutout.

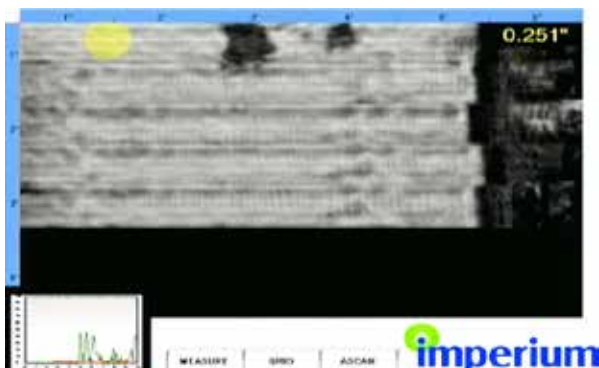
Figure 15. 2-dimensional stitched image of 1/4"-thick storage tank with area of corrosion identified.

As shown in **Figures 15 and 16**, the C-scan showed a typical thickness of about 1/4" and a thickness of 0.172" at a corrosion blister.

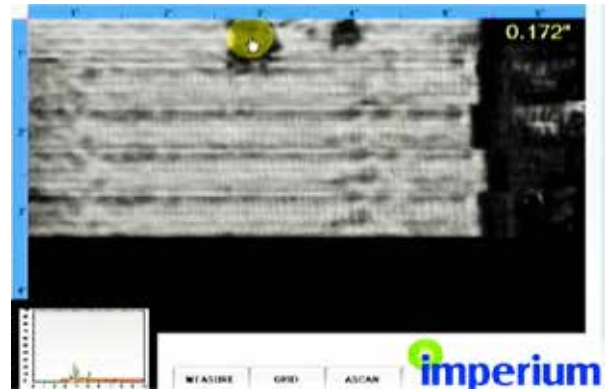
Figure 16. 2-dimensional stitched image of storage tank showing corrosion area with thickness of 0.172\"/>

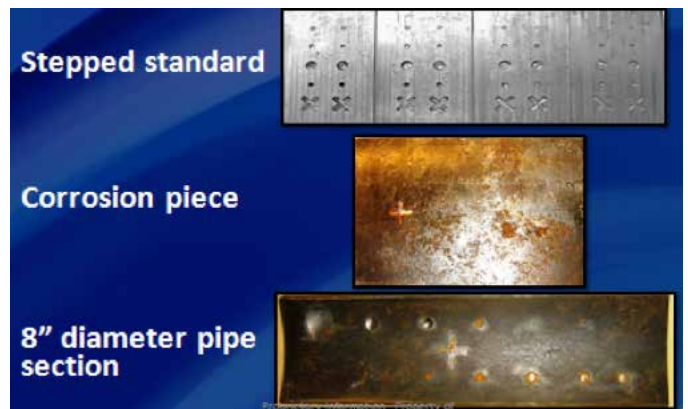
To document the system's effectiveness versus Phased Array, Imperium commissioned an independent third party to conduct an objective comparison. The system and a popular PAUT device were used to inspect three steel pieces: a stepped standard, a corroded panel, and an 8" diameter pipe (see **Figure 17**).

Figure 17. Targets studied in the "face to face" comparison.

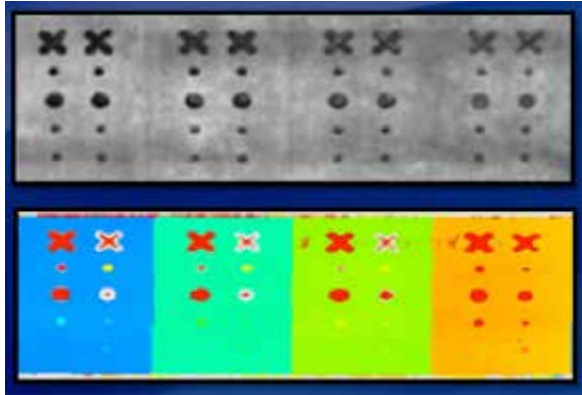
As shown in **Figure 18**, the system was superior in inspecting the stepped standard, producing a cleaner image and resolving smaller holes much more distinctly.

Figure 18. Results from stepped standard inspection.

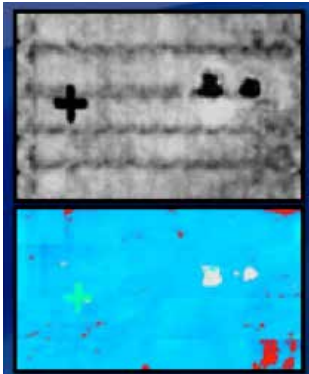
As shown in **Figure 19**, while inspecting the 1/4"-thick corroded steel panel, the system showed more distinct dark marks indicating damaged areas and produced fewer erroneous signals.

Figure 19. Results from inspection of corroded steel panel.

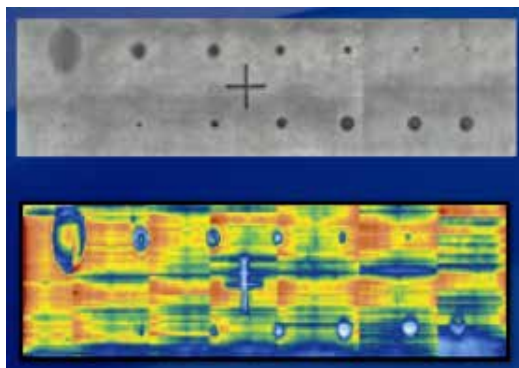
While inspecting the 8" diameter pipe, as shown in Figure 20, the system identified the rear surface cross mark and holes with helpful contrast, as compared to the confusing array of colors produced by the PAUT device.

Figure 20. Results from inspection of 8" diameter pipe.
