Scanning Results

Camera Scanning of Large Composite Structure

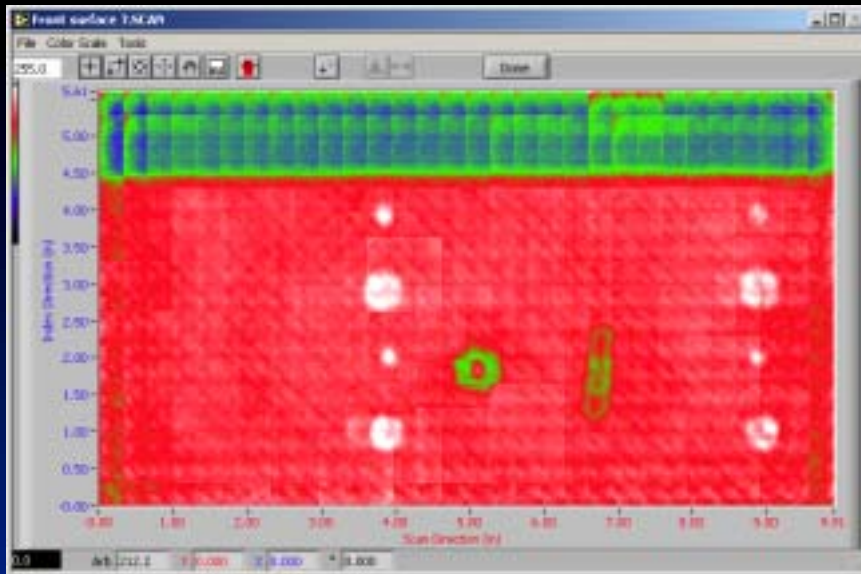
UT camera scan with stitching
algorithm applied
- 0.3" scan increment

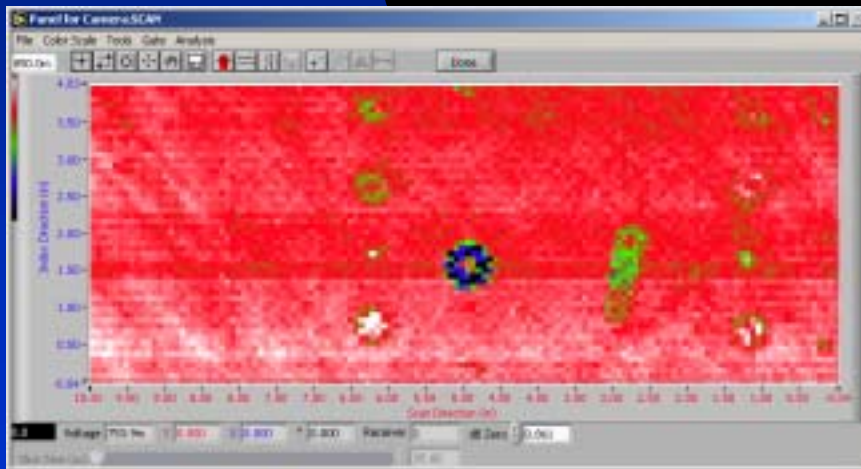
Conventional immersion scan
- 2.25 MHz, 0.25" diameter transducer
- 0.075 scan increment
